Ice Action on Riprap

Small-Scale Tests

CRREL Report 96-12

Cold Regions Research &
Engineering Laboratory

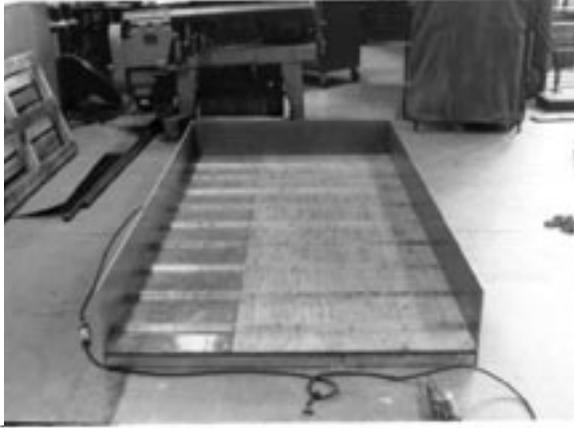
Figure 6. Aluminum box used for model riprap bank.

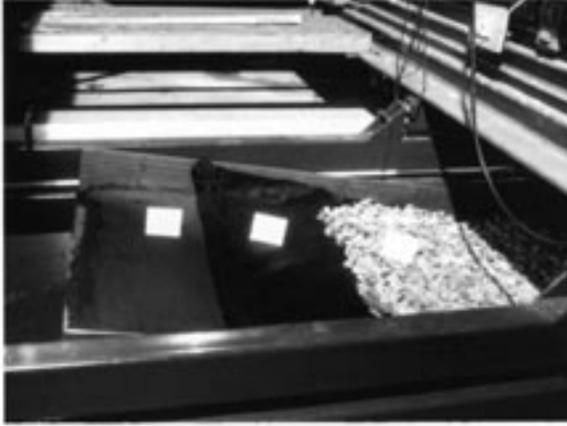
Figure 10. Partially installed layers of sand, filter fabric, and stones used to simulate a riprap-protected bank. In this view, the model and supporting platform are attached to the main carriage in the test basin.

The model bank riprap installation simulated a typical field installation as much as possible. We placed a 38-mm- (1.5-in.-) deep layer of sand on the bank (held in place by the transverse aluminum angle strips), covered the sand with a filter fabric, and placed manufactured stones to model the riprap material (Fig. 10). The practice in many field applications is to apply the riprap over a filter material, which prevents fine materials of an underlayer from being washed through the voids of a coarse upper layer. Where geotechnical conditions permit, a filter cloth (or geotextile) is often specified for the filter to lower construction costs. This type of filter material offers less frictional resistance to the riprap compared to a filter made of gravel. In previous laboratory studies on the angle of repose of riprap, the riprap was found to be less stable when placed on filter cloth than when placed on a simulated gravel filter. We used the filter cloth for the underlying filter material in our model, because the use of a filter fabric in our tests will better simulate the conditions for the growing number of bank protection projects using geotextile filters, and it will be conservative for those riprap installations using a gravel filter.

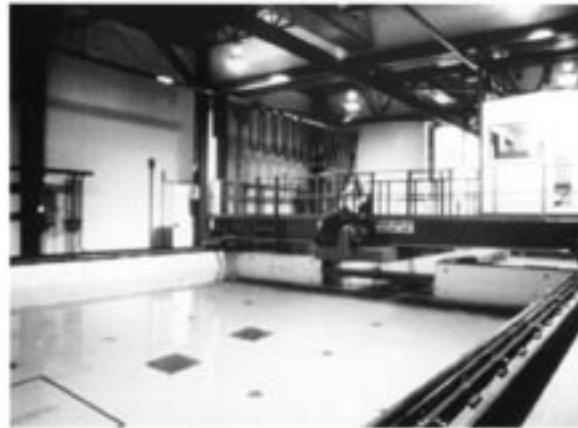
Figure 11 Refrigerated test basin in the Ice Engineering Facility.

The test basin at CRREL is 36.6 m (120 ft) long, 9.1 m (30 ft) wide, and 2.4 m (8 ft) deep (Fig. 11). It holds a solution of urea in water, 1% by weight, at a temperature of approximately 0°C (32°F). To grow an ice sheet, the temperature in the room is lowered to -10°C (14°F). The water is kept mixed with a bubbler system to prevent ice growth during this pull-down time. When the ambient temperature in the room reaches -10°C (14°F), we spray fresh water into the air above the water surface to seed an ice sheet. During the seeding process, ice crystals form in the air and fall onto the surface of the water. This seeding technique results in growth of small-size columnar ice crystals. The room is then cooled further to a temperature of -20°C (-4°F) to proceed with the ice growth.

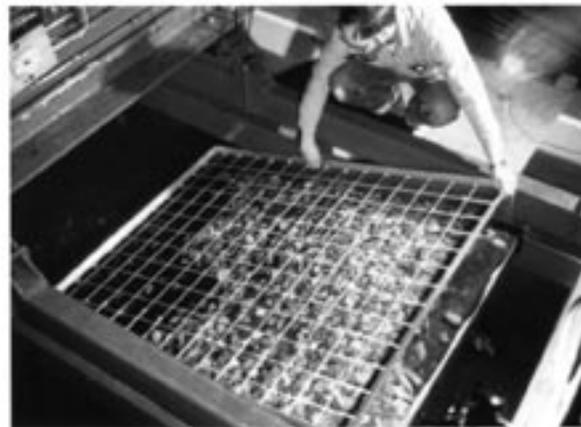
Figure 12. Placement of grid over the model riprap bank.

To profile the rock surface, we placed a frame containing a 102- \times 102-mm (4-in. \times 4-in.) grid made of strings (Fig. 12) on top of the fixed aluminum sides of the model bank, which provided a fixed reference for each set of measurements. With a ruler, we measured the perpendicular distances from the rock surface to the strings at each grid point (Fig. 13). The width of the grid frame was the same as that of the box (1.32 m or 52 in.) and its length was 1.52 m (60 in.). With this grid, we measured the riprap surface profiles at 168 grid points, which enabled us to get a reasonably good profile. We profiled the rocks before and after each

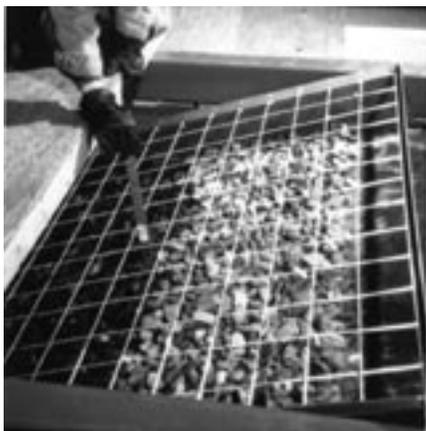
Figure 13. Measurement of the distance of the riprap surface from the strings at each grid point.

ice-free test. This technique provided a repeatable means of quantifying the amount of rock moved during a test by ice shoving.

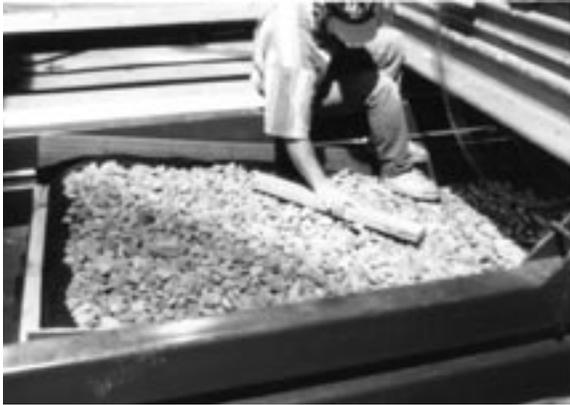
Figure 14. Leveling rocks of model riprap in final preparation prior to each test.

Before each test, we carefully leveled the rocks on the model riprap bank and filled in gaps in the riprap layer where necessary, as shown in Figure 14. The angle of the model bank was adjusted by changing the effective length of the support rods at the front (submerged) end of the model. Prior to freezing an ice sheet, we adjusted the water level in the test basin so that the model was submerged about halfway. We measured the water level relative to the model bank for each test and profiled the rocks using a grid technique explained above. We took photographs of the rocks directly above the model from a fixed vantage point before, dur-

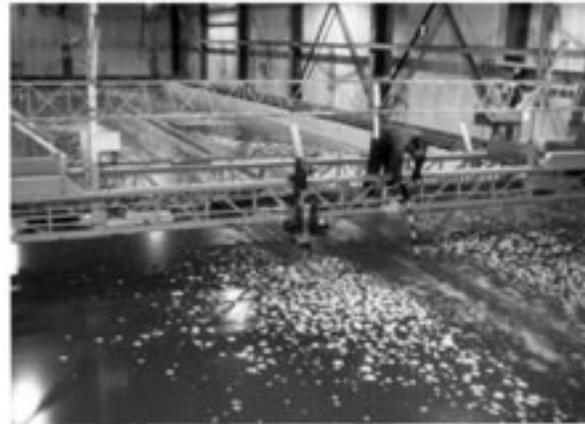
Figure 15. Cutting of slots in the model ice sheet prior to each test.

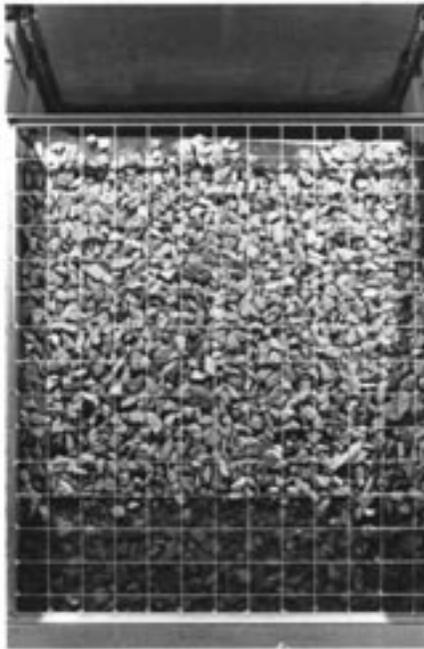
a. Before.

b. After.

Figure 17. Model riprap before and after a test in which ice rode up the bank.

We observed ice ride-up only during two tests: 3 and 18. The slope angle α of the bank in both these tests was 18.4° (1V:3H). During an ice ride-up event, we observed that the ice sheet was being pushed up the riprap slope and continually slid up and over the top edge of the model and back into the tank. During the ice ride-up events, the ice sheet dislodged some rocks upon initial impact, but generally did not displace enough rocks to expose the bank. Figure 16a shows an ice sheet riding up the model riprap bank for test 3. The action of the ice sheet sliding on top of the riprap shaved the underside of the ice sheet and filled in the interstitial spaces between the rocks, causing the riprap surface to become smooth. Figure 16b shows the riprap surface filled with ice shavings after we removed the ice sheet. Figure 17a and 17b show the riprap bank before and after test 3, respectively. As can be seen, there was very little displacement of the riprap.

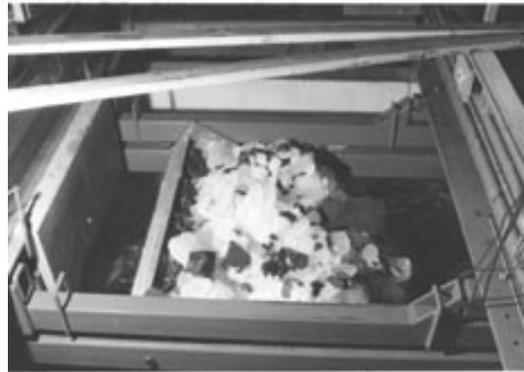
Figure 19. Stones brought up to the surface of an ice pile.

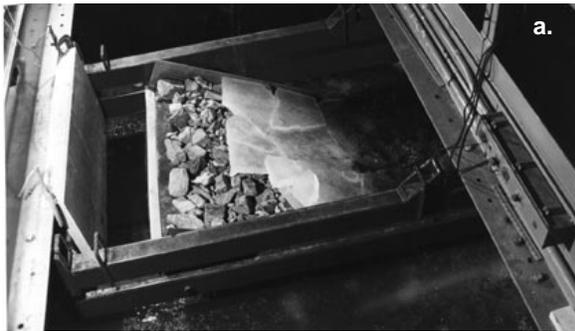
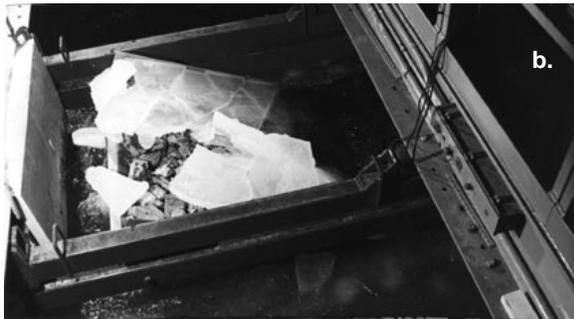
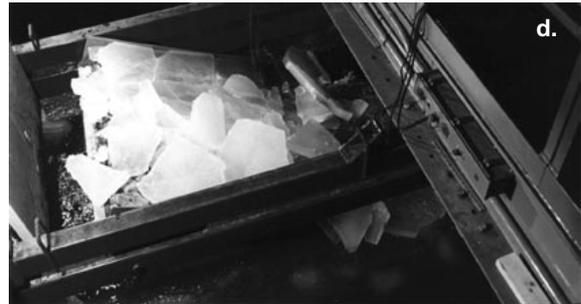
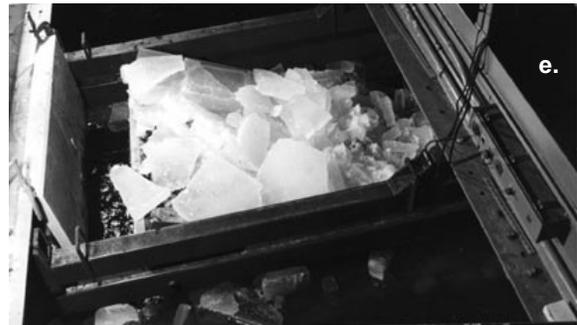
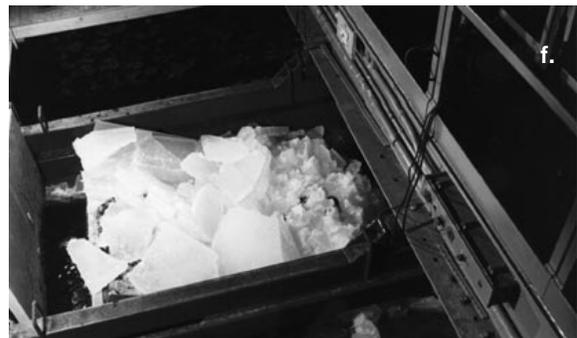
Figure 20. Sequence of ride-up and pileup events for test 20, in which the ice thickness was 53 mm (2.1 in.), and the bank slope was 27° (1V:2H).

mm (2.1 in.). As shown in Figure 20a, the ice sheet broke into roughly rectangular-shaped pieces approximately 25 cm (10 in.) square as soon as the ice sheet contacted the bank above the waterline. Figure 20b shows the broken-up ice sheet going over the top edge of the bank and starting to pile up on one side of the riprap bank. Figure 20c shows the ice sheet riding up and over the top edge of the bank on one side of the model, and beginning to pile up on the other side. As more of the ice sheet continued to shove onto the bank, the ice pieces stacked up on the previously deposited ice

pieces (Fig. 20d). At this stage, no ice was being pushed off at the top edge of the bank because all the ice pieces piled up high, creating a steep incline for the incoming ice sheet. Figure 20e and f show that the ice sheet piled up and crushed into the ice pile. In these last two views, it is possible to see rocks being brought to the surface of the ice pile by the ice sheet. We observed the rocks being transported from the bed to the surface of the ice pile during most of the tests in which the ice piled up on the bank.

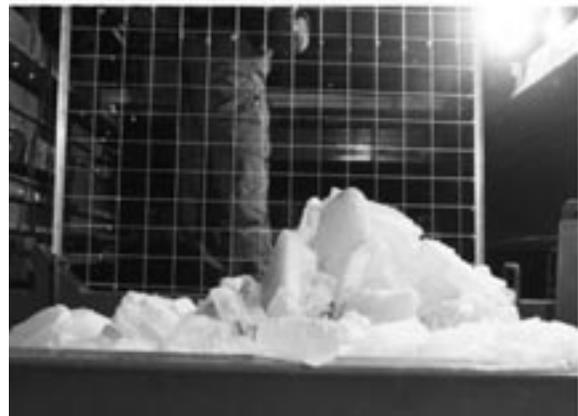
Figure 24. Ice pileup after test 4.

An ice pileup most often caused failure of the riprap when the advancing ice sheet was forced to go between the riprap and the piled up ice. In general, we defined the riprap to have failed if enough rock material was displaced to expose underlying areas of the riprap-protected bank. For example, the ice piled up significantly in test 4, as shown in Figure 24. During that test, the ice gouged away enough riprap to expose large areas of the bank, as shown in Figure 25. In test 5, an ice pileup formed below the water line, as can be seen by the damage to riprap shown in Figure 26. Figures 27a and b show the contour plots of the rock profile data taken before and after test 5. Such contour plots help to visualize the total displacement of the riprap during a test. The contour plots

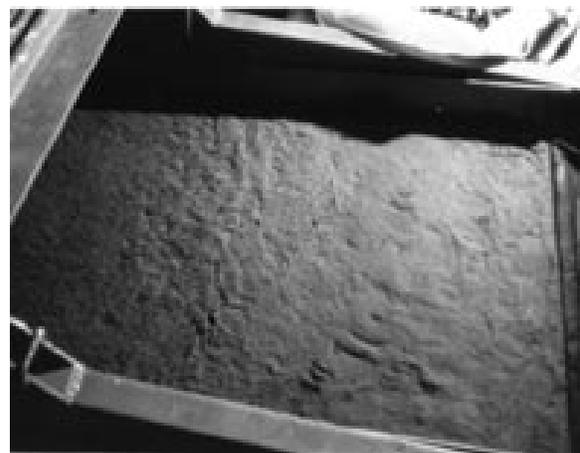
Figure 29. Sand bed of model bank deformed by ice action after test 8.

After an ice run on the smallest stone size (test 8), we observed that the ice sheet had deformed the sand bed as well as the riprap, as shown in Figure 29. After test 30, we observed a far greater amount of ice damage than usually encountered; the ice tore the filter fabric (Fig. 30). These observations indi-
